SECTION VI

CASE STUDIES

**Neal A. Vogel
Project Director**

March, 1996

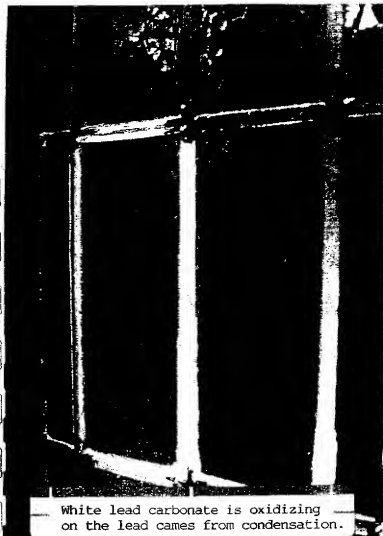
White lead carbonate is oxidizing
on the lead came from condensation.

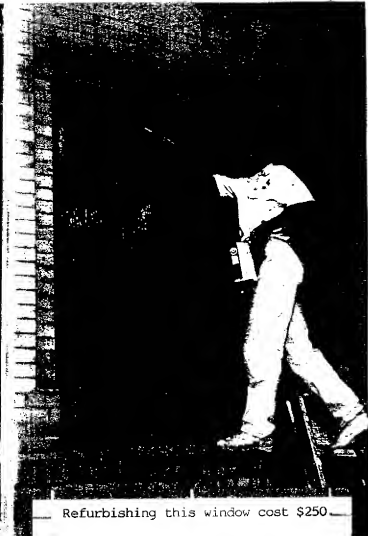
Refurbishing this window cost \$250.

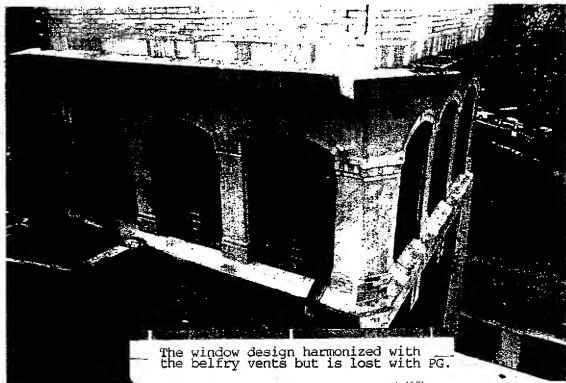
The window design harmonized with
the belfry vents but is lost with PG.

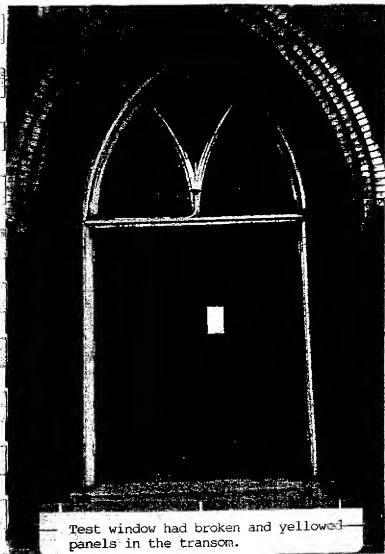
Test window had broken and yellowed panels in the transom.

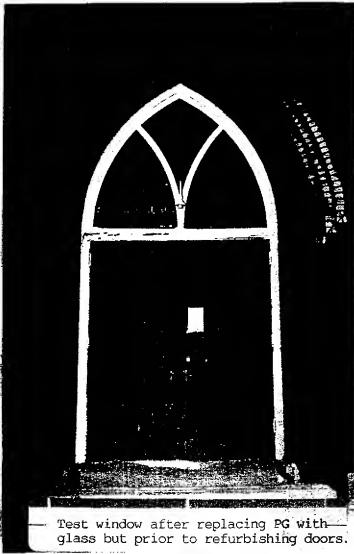
Test window after replacing PG with glass but prior to refurbishing doors.

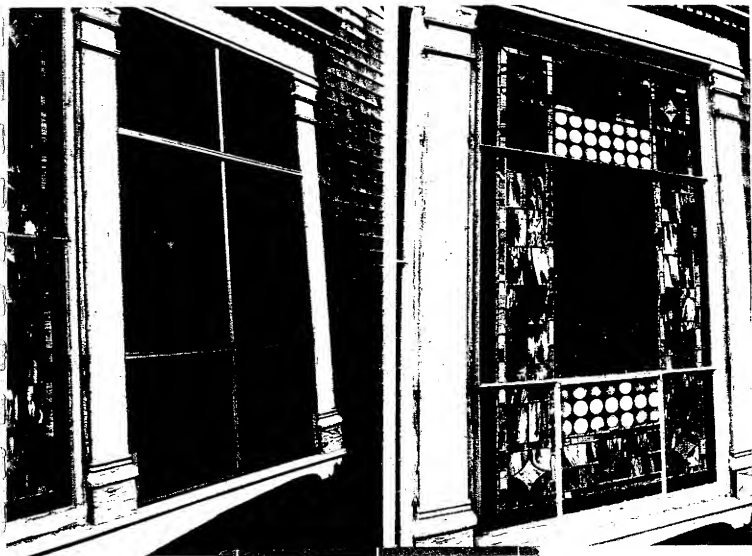
— Removal of the hazed PG revealed the brightly colored glass behind.

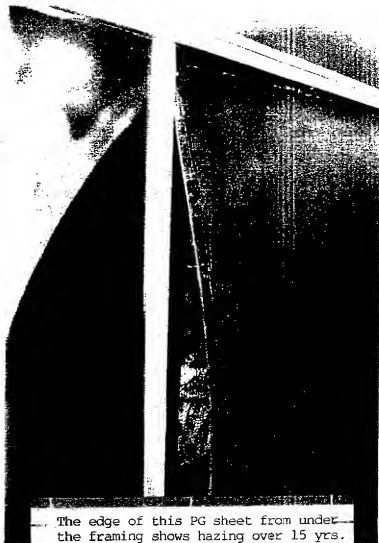
The edge of this PG sheet from under the framing shows hazing over 15 yrs.

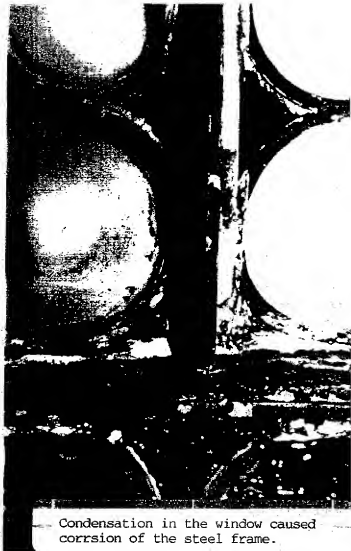
Condensation in the window caused corrosion of the steel frame.

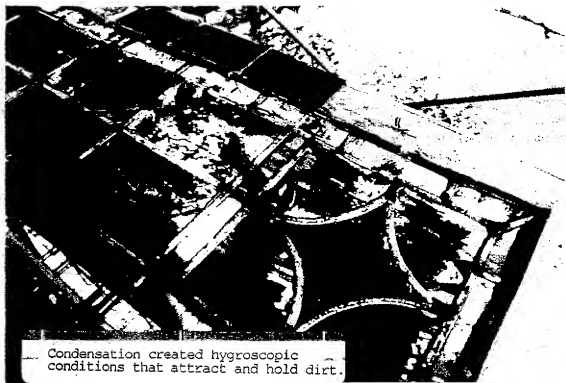
Condensation created hygroscopic conditions that attract and hold dirt.

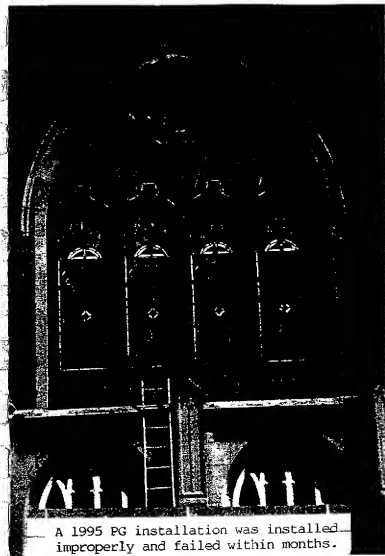
A 1995 PG installation was installed improperly and failed within months.

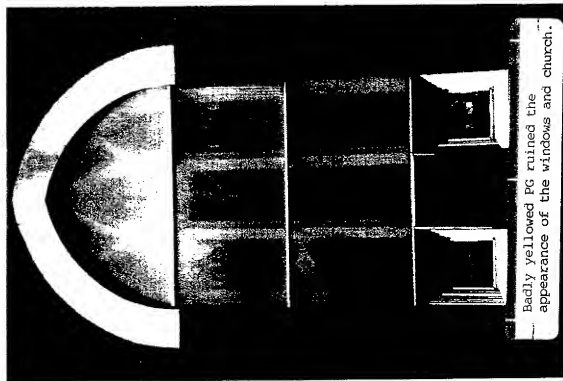
Badly yellowed PG ruined the appearance of the windows and church.

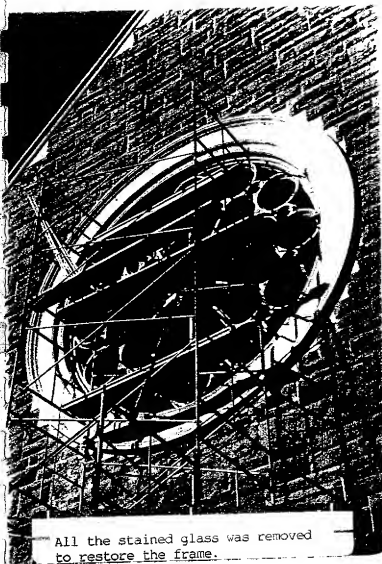
All the stained glass was removed to restore the frame.

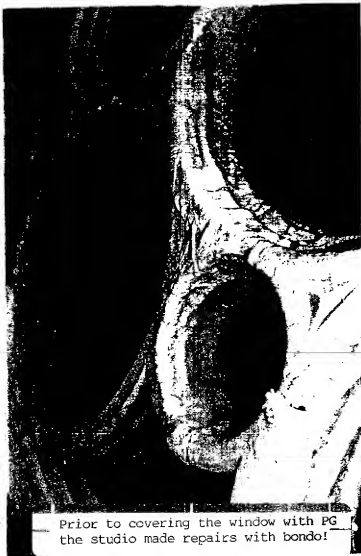
Prior to covering the window with PG the studio made repairs with bondo!

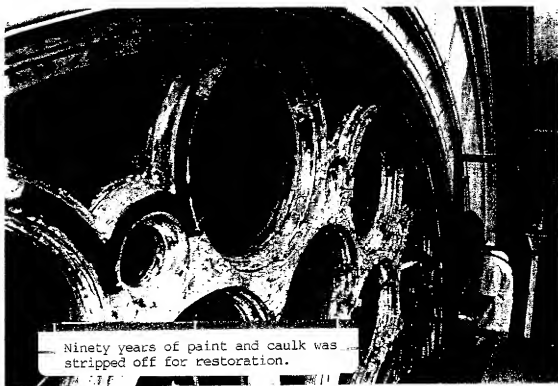
Ninety years of paint and caulk was stripped off for restoration.

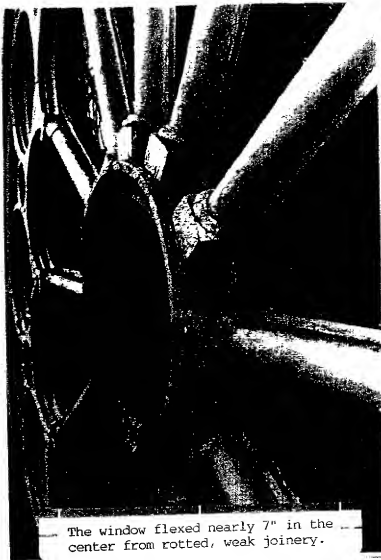
The window flexed nearly 7" in the center from rotted, weak joinery.

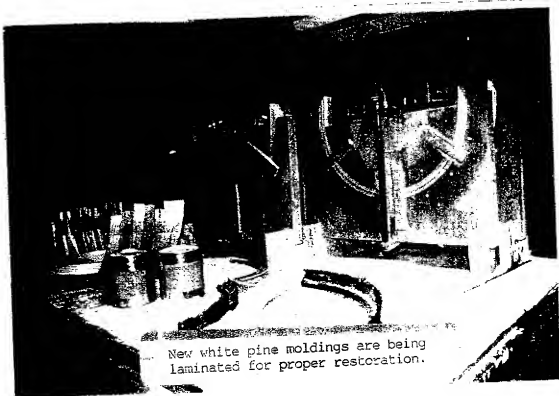
New white pine moldings are being laminated for proper restoration.

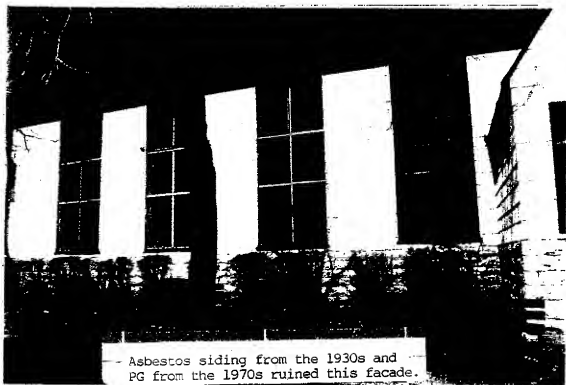
— Asbestos siding from the 1930s and PG from the 1970s ruined this facade.

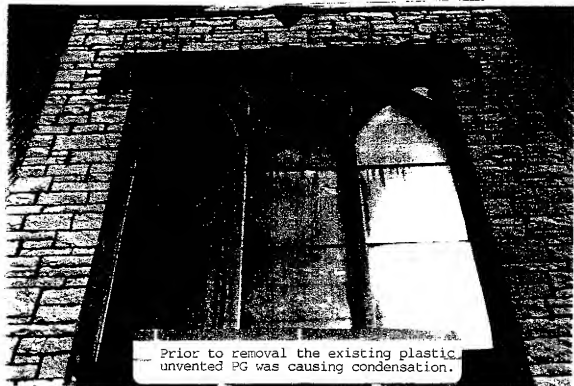
Prior to removal the existing plastic unvented PG was causing condensation.

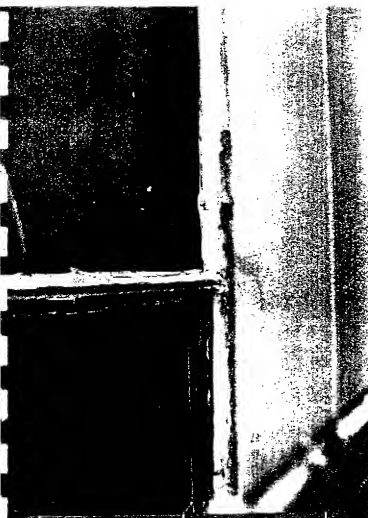
Sealants had been applied poorly on the existing PG.

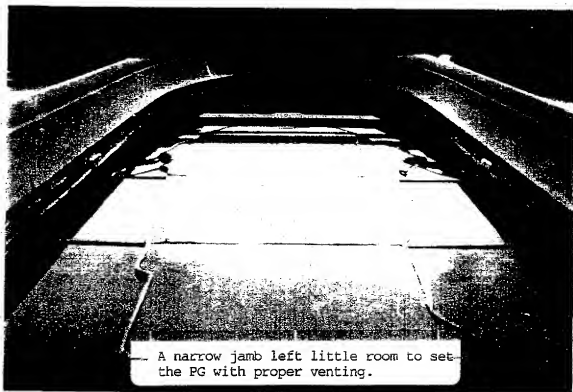
A narrow jamb left little room to set the PG with proper venting.

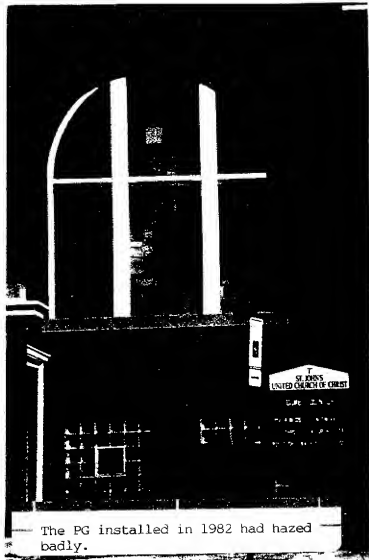
The PG installed in 1982 had hazed badly.

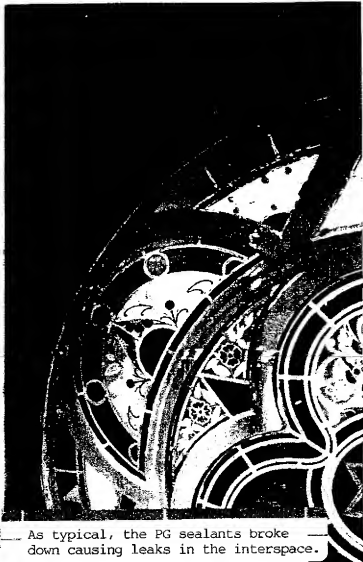
As typical, the PG sealants broke down causing leaks in the interspace.

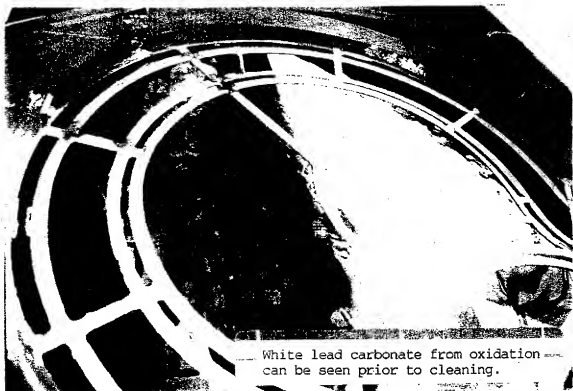
White lead carbonate from oxidation can be seen prior to cleaning.

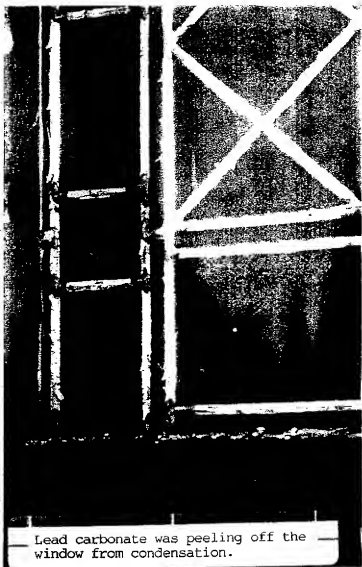
Lead carbonate was peeling off the window from condensation.
